**ENGINEERING GEOLOGICAL CHARACTERISATION
OF THE TORLESSE COMPOSITE TERRANE IN
CANTERBURY, NEW ZEALAND
WITH REFERENCE TO MECHANISED TUNNELLING**

A thesis
submitted in partial fulfilment of the requirements for the degree of
Master of Science in Engineering Geology
at the
University of Canterbury
by

**ADAM GRANT IRVINE
2013**

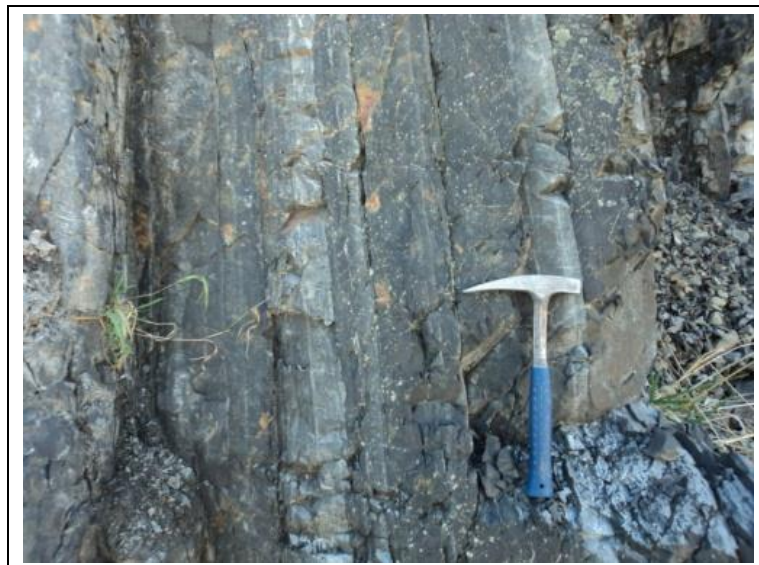
Figure 3.4: Gradational bedding within the thinly bedded members at outcrop 3a, Elliott Fault.

Fault footwall rock, some 110 m outside the main zone of faulting is in relatively good condition and does not give any indication of structural damage. A large proportion of thinly bedded sandstone-mudstone sequences are observed (outcrops 1a-e, 3a, see Appendix D.3). The bedding displays gradational changes from fine to coarser sandstone and mudstone (Figure 3.4). The thin bedding is in relatively good condition, however, it remains highly fractured to fragmented. Other thinly interbedded rock (outcrop 5b) has distinctive bedding planes and the rock mass appeared worse as a result. Two main shear zones in excess of 2 m were observed within thinly bedded members away from the active trace (Figure 3.5). More intact rock of greater thicknesses was observed (4a, 5k, 6a, 6b, 12a). This rock mass is the best observed in the study site. Degree of fracturing is dominantly moderate to highly fractured and there is no indication of ground water. Persistent jointing is identified within the range of bedding thicknesses at the Elliott Fault which differs from jointing patterns observed elsewhere (Appendix D.3).

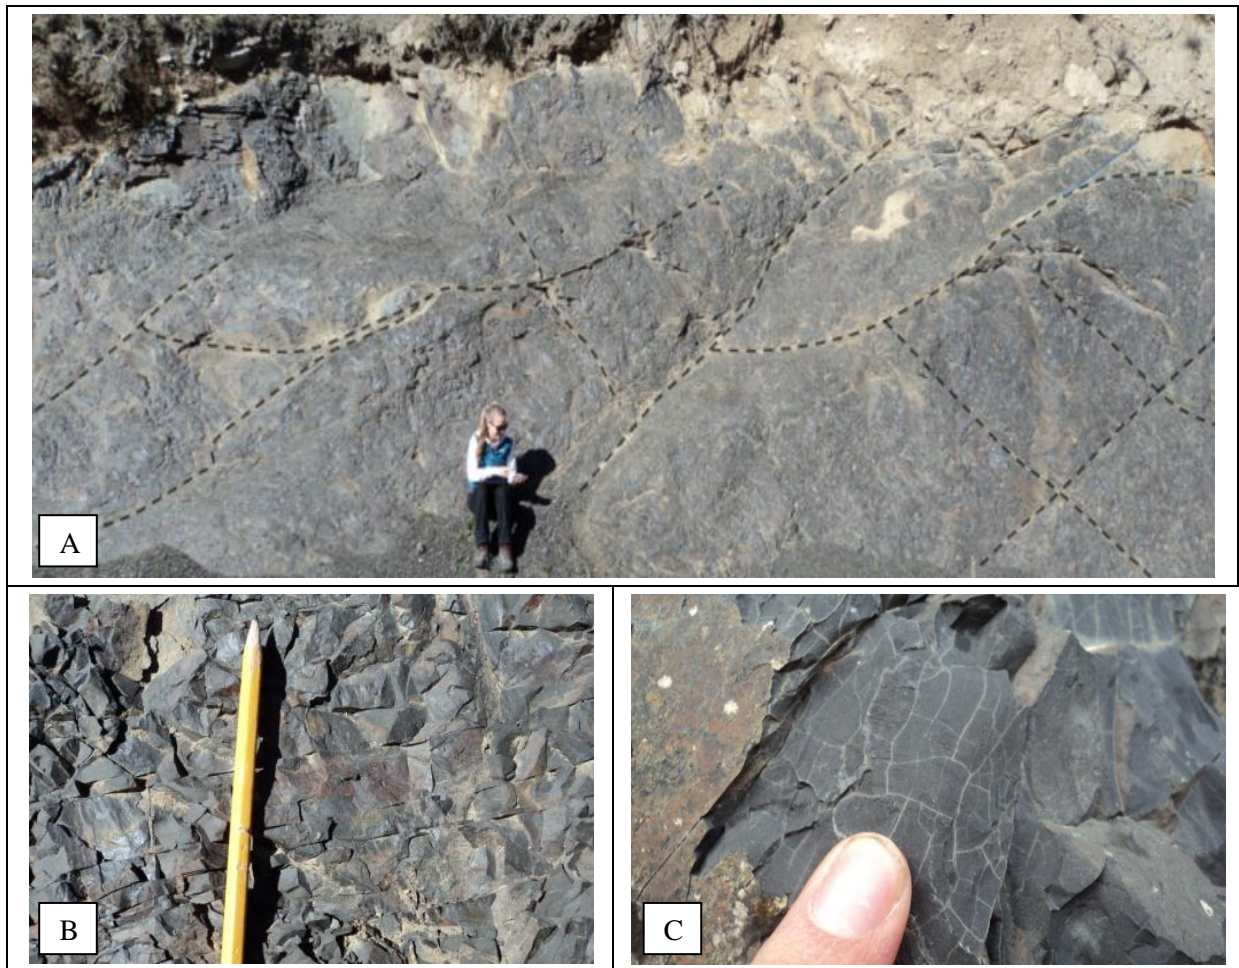
Figure 3.11: A: very thickly bedded mudstone with heavy shearing indicated; B: fragmented nature of the mudstone lithotype; C: incipient fracturing occurring within fragmented mudstone blocks.

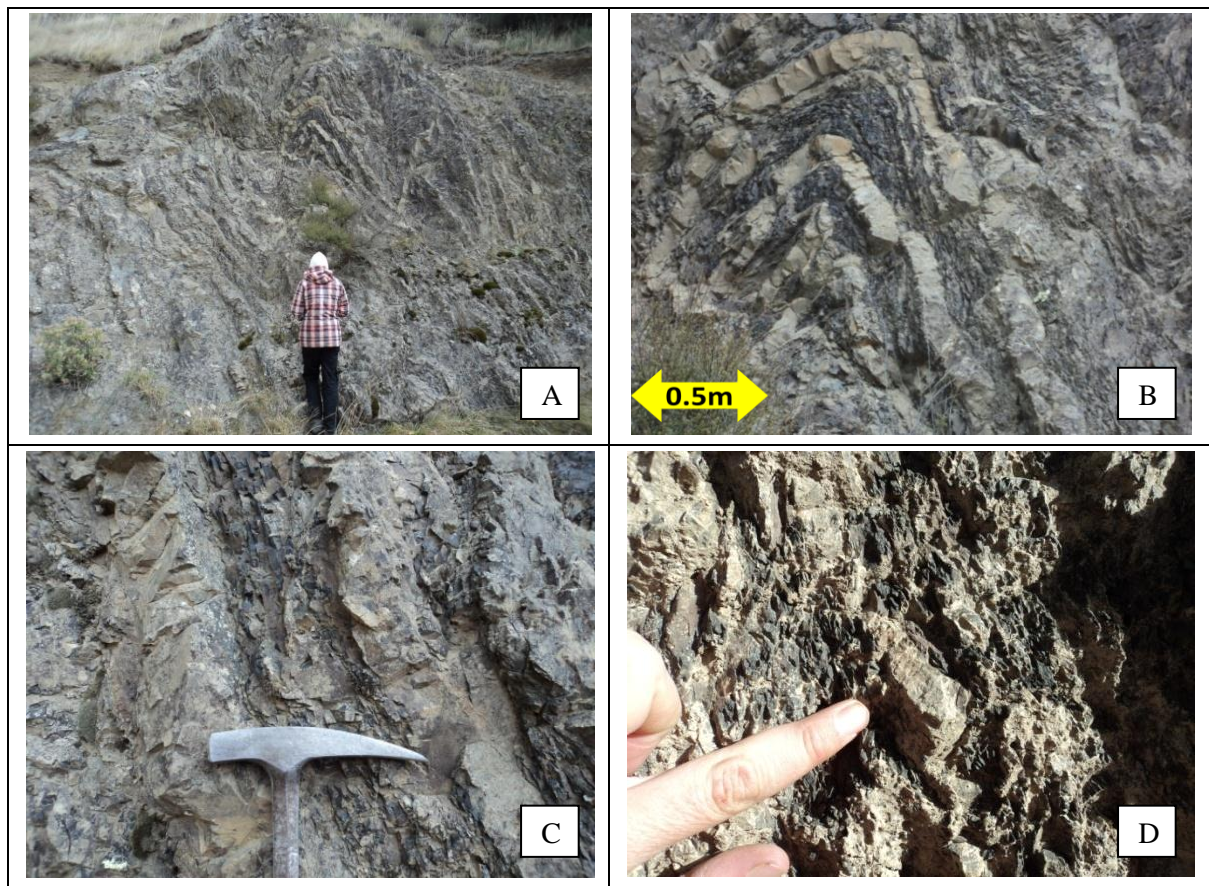
Figure 3.12: A & B: folding and faulting concentration in the thinly bedded member; C: fragmented fracture density; D: centimetre scale sandstone boudinage encased in mudstone matrix.

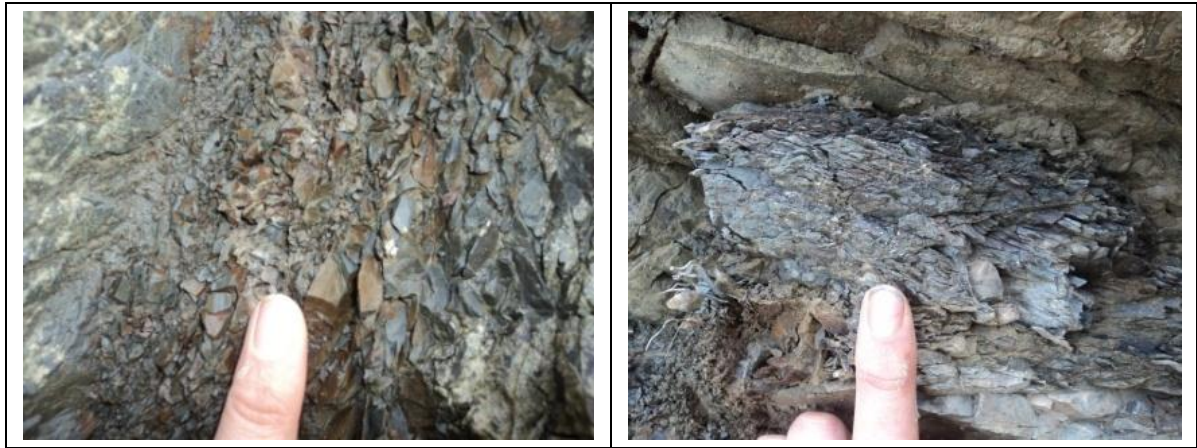
Figure 3.15: Broken formation observed throughout the Hurunui River study site.

Fragmented, layer parallel sheared mudstone is indicative of the Broken Formation (after Rattenbury et al. (2006)). It was observed in all mudstone bedding throughout both structural blocks regardless of bedding thickness, however was more evident within the thinner mudstone member. Typically fracture was lineated parallel with bedding indicating layer parallel shearing (Figure 3.15). Due to the level of weathering, slickenside was not easily observed to confirm this hypothesis. Broken Formation was observed throughout the whole study site, however was more evident within the MNSZ.

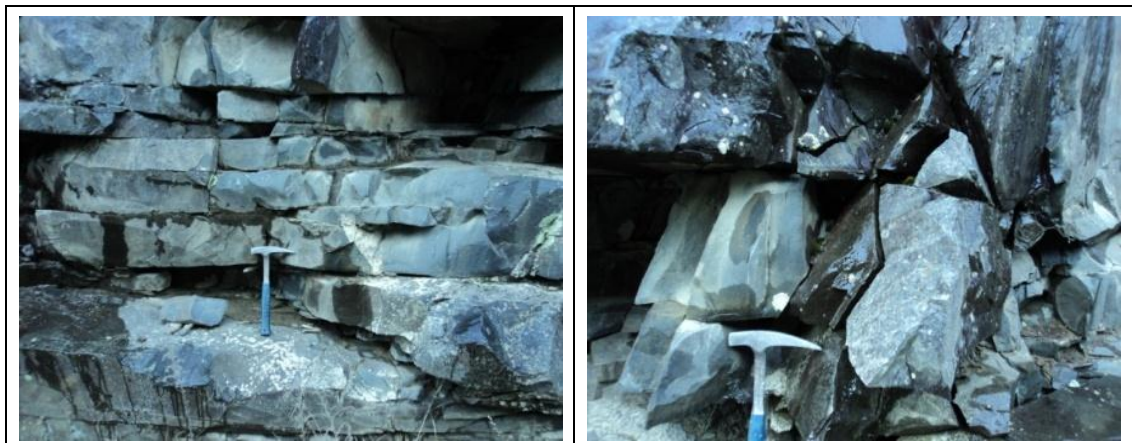
Figure 3.16: Indication of ground water nature flowing through open horizontal jointing.

Little indication of groundwater condition was given throughout the entirety of the study site. Outcrop 15a had the only indication of ground water condition (Figure 3.16). Defect surfaces were wet and water was observed dripping from relatively open, horizontal jointing.

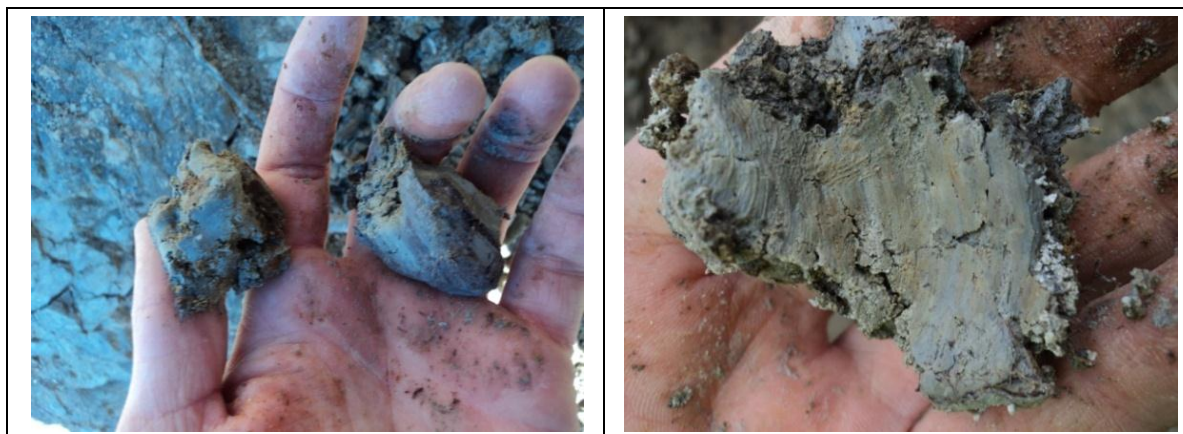
Figure 3.18: Clay fault gouge. Left: outcrop 18a; right: outcrop 23b (sample 23b – clay).

Similar to the Elliott Fault site occurrence of infilling was dominant toward faults and shears. Bedding remained clean ignoring the development of fragmented mudstone not foreign to the surface (Figure 3.17). Jointing was dominantly clean. Defect staining should be anticipated where groundwater is likely to be flowing through interconnected defects where adequate aperture exist. The lack of groundwater flowing through surficial outcrops and extended periods of surface weathering has meant evident stained surfaces are rare. Silt is the dominant infilling fraction. Plastic, clay sized gouge was observed in some select faults and shears (Figure 3.18). The material exhibited clay properties with slight plasticity. The material was moist and hosted millimetre scale intact granules. The material occurred in zones less than 10 cm in size and has been termed gouge. Faulting and subsequent infilling was particularly abundant throughout outcrop 23 which may be related to external influences.

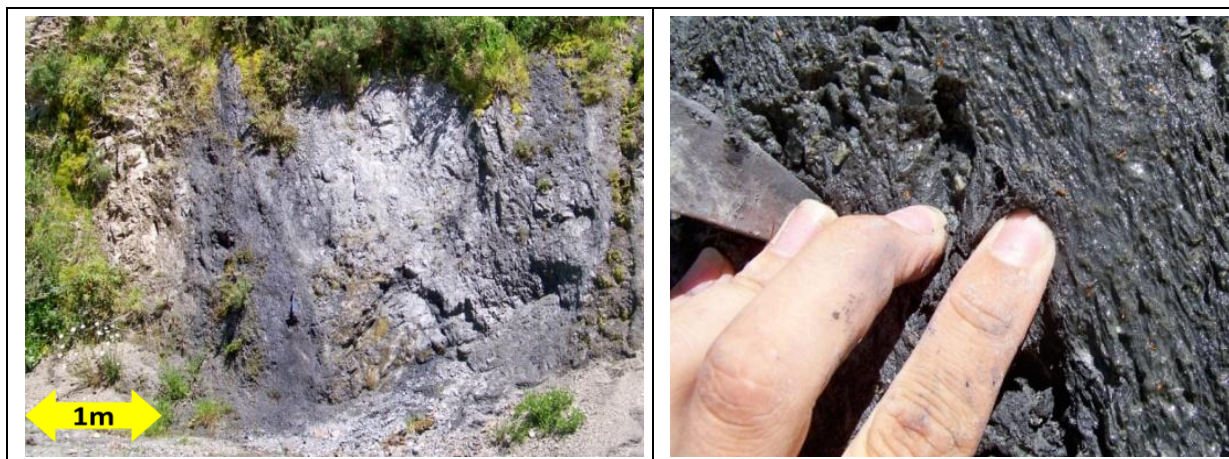
Figure 3.25: Left: mudstone bedding shear; right: firm mudstone shear material.

An approximately 1 m shear is observed running layer parallel along a thickly bedded mudstone (outcrop 13a, Figure 3.25). The mudstone material is described as a firm gouge and is lineated parallel to bedding. Sandstone bordering the mudstone bed has a 4 m crush zone before rock mass condition improves but remains fragmented.

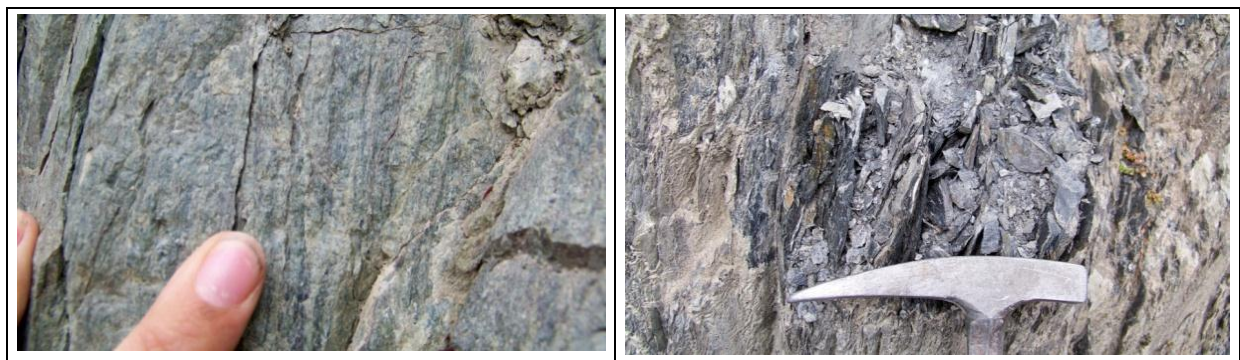
Figure 3.31: Green and cleaved black mudstone observed along the Glentui Fault crush zone.

Red, green and black mudstone was observed along the Glentui Fault crush zone (Figure 3.31). The material was not directly concerned with this study, however of note was cleaved black mudstone. The black mudstone is fragmented and cleavage planes have developed parallel to bedding. Of similar character, the green mudstone has developed schistosity planes in response to faulting. It is likely the formation of the planes have formed at depth before uplift to the current elevation.

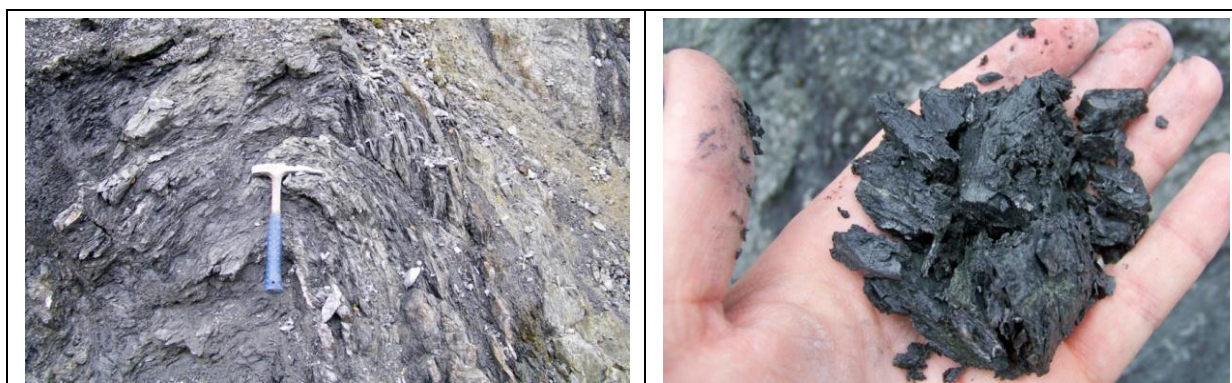
Figure 3.37: Left: wavy thinly interbedded lithotype bordering the Opuha Dam Fault, outcrop 5a; right: cleaved mudstone, outcrop 5a.

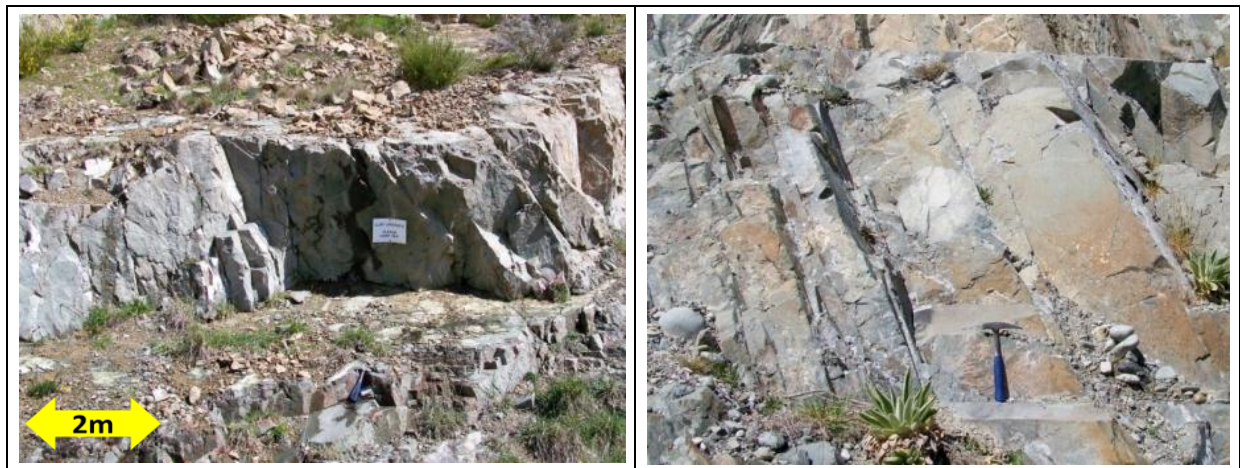
Figure 3.43: Left: joint controlled rock mass at outcrop 1g; right: blockiness nature of persistent jointing observed at outcrop 9a.

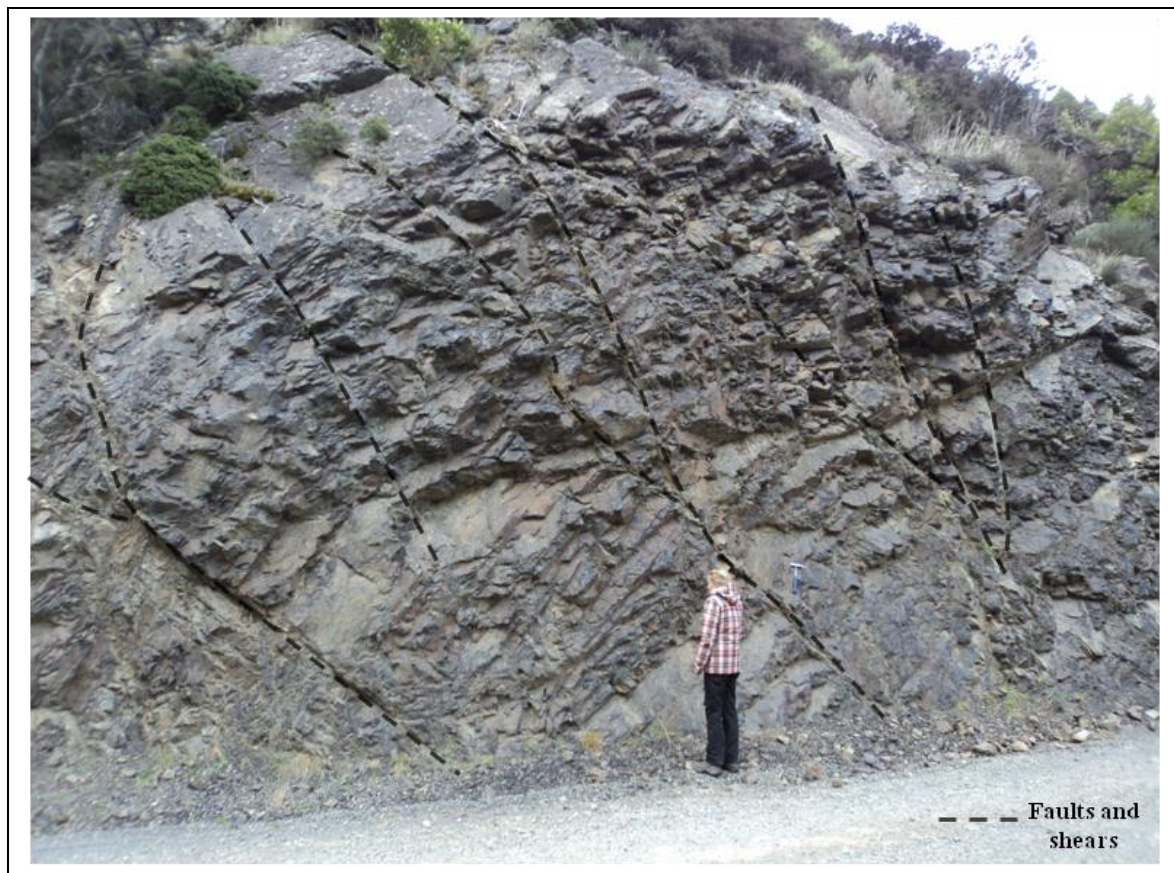
Figure 4.6 (continued): Top: Ashley 22a very thinly interbedded sandstone-mudstone sequence with abundant faults and shears indicated; bottom: Hurunui 13c thin interbedded sandstone-mudstone sequence with faults and shears indicated.

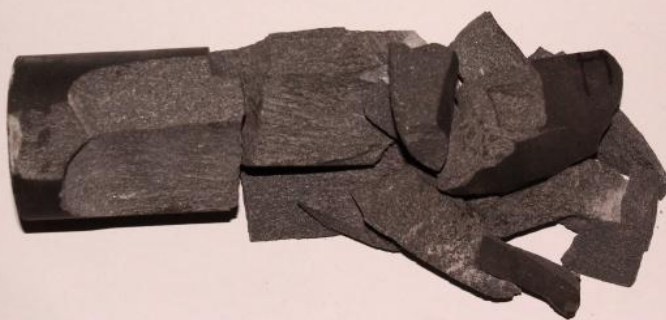
CLIENT:	Pells Sullivan Meynink Pty Ltd	
PROJECT:	TBM Research - NZ	AFTER TEST
LAB SAMPLE No.	13020222	DATE: 26/2/13
BOREHOLE:	1 - Hurunui River - H-29-A	DEPTH: Not Supplied

Client	Pells Sullivan Meynink Pty Ltd	Report No.	13020222-MOD
Project	TBM Research - NZ	Test Date	26/02/2013
		Report Date	27/02/2013
Client ID	1 - Hurunui River - H-29-A	Depth (m)	Not Supplied
Description	-		
Uniaxial Compressive Strength 232 MPa			
Average Sample Diameter (mm)	49.4	Moisture Content (%)	0.2
Sample Height (mm)	129.3	Wet Density (t/m ³)	2.66
Duration of Test (min)	10.87	Dry Density (t/m ³)	2.66
Rate of Loading (MPa/min)	21.37	Bedding (°)	Nil
Mode of Failure	Disintegration	Test Apparatus	Kelba 1000kN Load Cell
Specific Energy (MJ/m ³)	0.024		
Specific energy determined from area under curve between 0 and 904µε

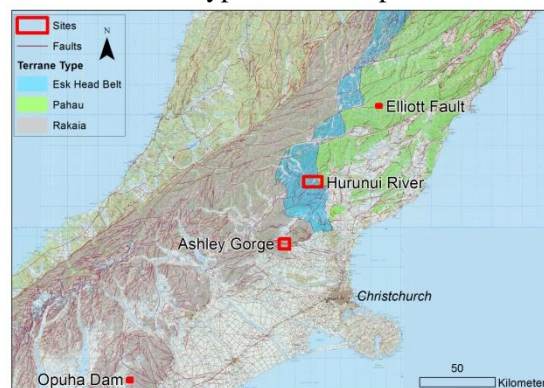
Figure 1: Torlesse terrane and study sites. Data sourced and modified from Rattenbury et al. (2006), Nathan et al. (2002), Forsyth et al. (2008) and Cox and Barrell (2007).

Four study areas, the Elliott Fault, Hurunui River, Ashley River Gorge and Opuha Dam, were selected on the basis of obtaining representation across the suite of Torlesse (Figure 1). The four sites were chosen to represent all terrane types, metamorphic facies and structural styles.

The Torlesse is sub-divided into two terrane types, distinguished by age, and a third sub-terrane (Figure 1). The older Rakaia terrane is the largest by area (Cox and Barrell, 2007). It is widely deformed and monotonous (Mortimer, 2004). The Pahau terrane is the youngest and is separated from the Rakaia terrane by the third (sub) terrane in the study region, the Esk Head Belt. The Esk Head Belt is described as a zone of more sheared rock dominantly comprising Rakaia and Pahau Torlesse (Rattenbury et al., 2006). The sandstone in the Pahau has a slightly lighter colour and induration than the Rakaia terrane ((Forsyth et al., 2008, Rattenbury et al., 2006).
